Fatigue assessment of the collapsed XXth Century cable-stayed Polcevera Bridge in Genoa

25th International Conference on Fracture and Structural Integrity

Fatigue assessment of the collapsed XXth Century cable-stayed
Polcevera Bridge in GenoaStefano Invernizzi^{a,*}, Francesco Montagnoli^a, Alberto Carpinteri^a^aPolitecnico di Torino, Corso Duca degli Abruzzi 24, Torino, 10129, Italy**Abstract**

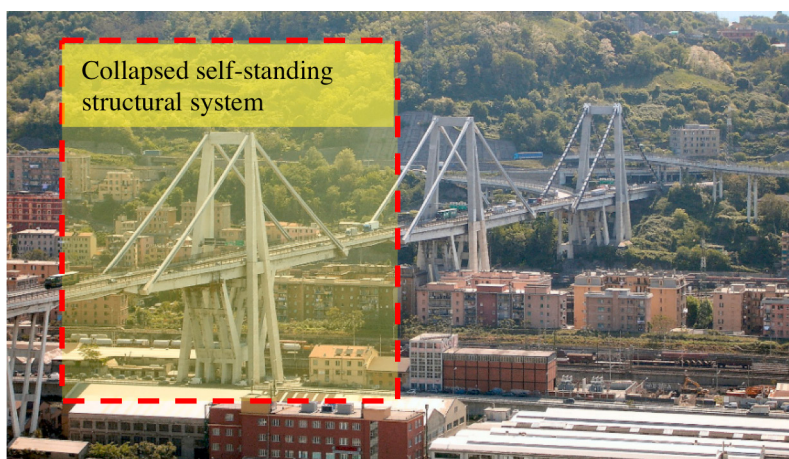
Fig. 1. Three self-standing structural systems of Polcevera Bridge.

The Polcevera viaduct was a complex structure, which was composed by several minor spans and three main spans, besides all the connecting ramps. The collapsed part of the viaduct was linked with the adjacent parts of the bridge by means of two statically determinate Gerber beams of 36 m span each, which have been involved in the collapse (Fig. 1).

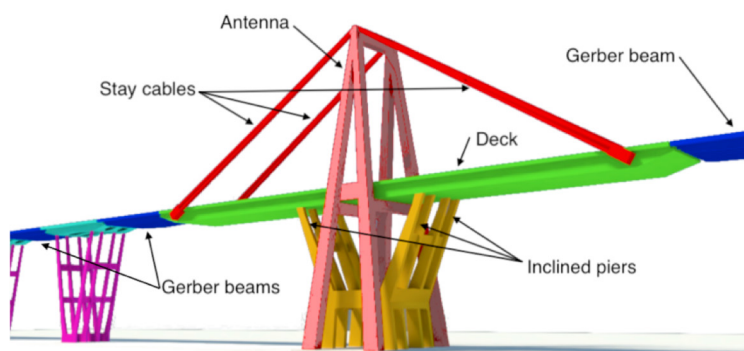
Fig. 2. Structural components of the self-sustained system.

The deck of the self-sustained system was a multi-cell box girder 4.5 m deep and 171.9 m wide, which was supported at four points by inclined piers and two couples of stay cables (yellow and red elements in Fig. 2, respectively) hanged at the top of the A-shaped antenna. Four transverse beams, orthogonal to the girder, had the purpose to link the deck to the piers and to the stay cables.

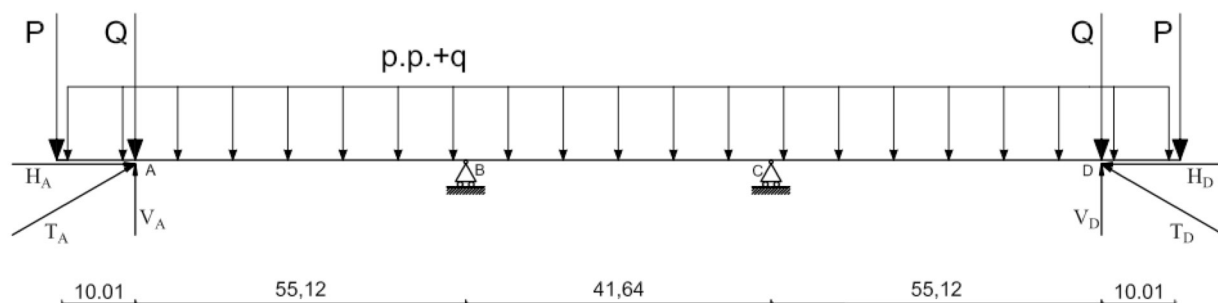
Fig. 3. Static scheme used for the evaluation of stresses in the stay cables due to the permanent loads.

According to Morandi's design concept (Morandi, 1967), the principal stay cables were supposed to support the permanent loads. The tension in the strands was set such as the vertical displacement of the deck at the connection point with the stay cables would vanish. As a consequence, the static scheme shown in Fig. 3 allows for an easy determination of the axial force in the two couples of stay cables due to the permanent loads, whose values are reported in Tab. 1. The tensile forces in the stay cables are obtained by projection of the vertical reaction forces in A and D on the cable direction. The statically indeterminate reactions in A and D are identical due to structural symmetry and can be derived imposing compatibility equations.

Notice that the construction process was highly complex also because of the use of temporary strands, which were removed once the main stays were in place. It is worth noting that, the structural scheme represented in Fig. 3 provides the value of the axial force in the stay cables with a good approximation.

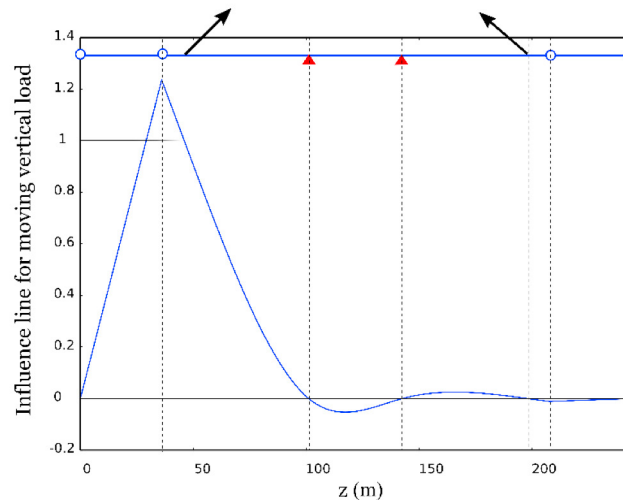
Fig. 4. Influence line of vertical reaction V_A for moving vertical load.

If we consider the couple of stay cables that support the deck at point A, in order to assess the stress range in each cable, it is necessary to calculate the influence line of the vertical reaction due to vertical moving unit load. Thanks to the reciprocity theorem, this is equivalent to trace the deflection line corresponding to the imposed unit deflection at the point A. The stress in the stay cable can be subsequently obtained by projection according to Eq. (1).

Fig. 4 shows the obtained line of influence. Taking into consideration the safety distance between lorries and according to the standard prescription, it appears that each heavy vehicle will correspond to one main load cycle (EN 1991-2, 2003). The amplitude of the cycle can be calculated multiplying the weight of the lorry by the difference between the highest peak and the lowest valley values of the influence line.

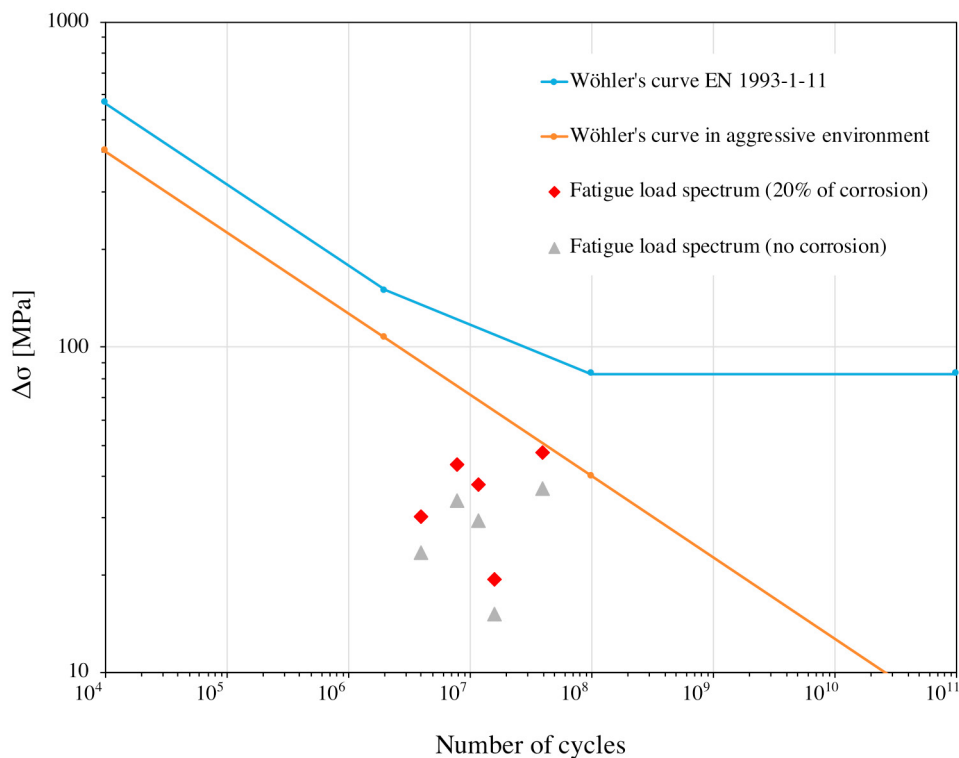
Fig. 5. Application of Palmgren-Miner's rule according to different corrosion scenarios.

Different scenarios can be considered, as shown in Fig. 5. If no corrosion is considered, Wöhler's curve is provided by EN 1993-1-11 (2006) and the failure due to the damage accumulation for the given fatigue load spectrum can be excluded. If the aggressive environment is considered, Wöhler's curve changes, because the curve is translated downwards and because the horizontal asymptote is missing (Løtsberg, 2016). Analogous modification of Wöhler's curve would be obtained if the influence of structural size were additionally considered (Carpinteri & Montagnoli, 2018).

In this context, it is possible to look for the level of absolute corrosion necessary for the damage accumulation to approach unity. Since Eq.(3) can not be inverted directly, the calculation must be performed iteratively. The critical level of corrosion is estimated to be approximately equal to 20%. It is worth noting that the level of corrosion detected during inspections, carried out in 2015, was estimated comprised between 10% and 20% (Relazione Commissione Ispettiva Mit, 2018). In addition, recent analyses carried out on the bridge's stay cable ruins (Filetto et al., 2019) provided that at least 22% of strands showed a very high level of corrosion comprised between 50% and 70%, whereas in the remaining 78% the lower level of corrosion was comprised between 30% and 50%. As a consequence, it is conservative assuming an overall level of corrosion approximately of 35%. It is worth noting that the critical level of corrosion with respect to the static load is much higher, and above 60% (Calvi et al., 2018). In addition, if the decompression of the concrete did not occur, the stress range in the tendons would have been much lower and the critical accumulated damage would have been avoided. Finally, it is evident that the concept of fatigue limit can be unsafe, and that is worthy of deeper investigations in order to better account for the influence of aggressive environment, structural size-scale, and damage accumulation in very-high cycle regime.
